RAILWAY INVESTIGATION REPORT

R01W0007

DERAILMENT

CANADIAN PACIFIC RAILWAY

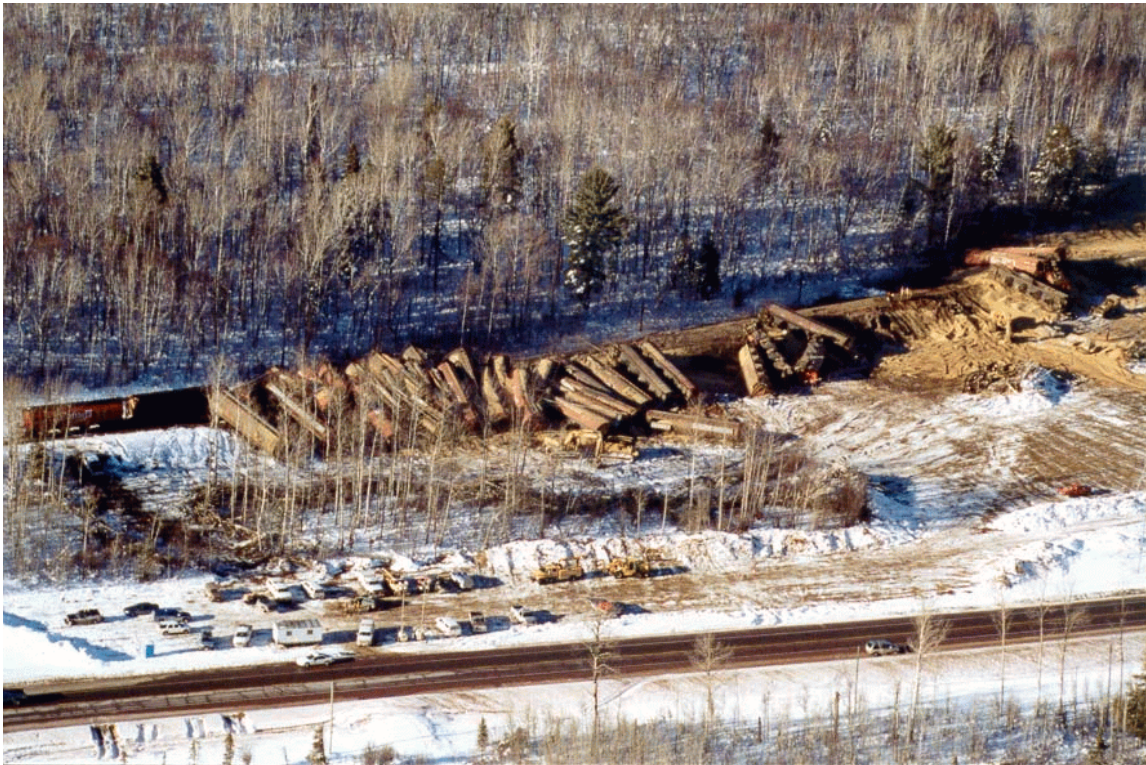
On 08 January 2001, Canadian Pacific Railway (CPR) train 308-001 (train 308) departed Thunder Bay, Ontario, Mile 132.9 of the Nipigon Subdivision, at 1050 eastern standard time.¹ At about 1330, the eastward train experienced a train-initiated emergency brake application at Mile 94.297 while descending a 0.55 per cent grade, west of Bowker, Ontario. The train was travelling at 64 mph in a maximum allowable speed zone of 50 mph. After emergency procedures were executed, inspection of the train revealed that a total of 59 cars had derailed, the 12th car and the 19th to 76th cars, inclusive. The north and south rails were fractured within a few metres of the initial point of derailment (POD) at Mile 94.65. Initial examination of the POD revealed that the track had spread, the high rail canted over and the wheels dropped between the rails, resulting in a derailment. The head end of the train, with 19 cars, travelled approximately 4500 feet after the derailment occurred. The 12th car and the 19th car were derailed and upright on the roadbed. The 20th to 24th cars were derailed and on their side to the south of the track, approximately 2000 feet behind the head end of the train. The 25th to 76th cars were derailed in an accordion fashion on the right-of-way for a distance of 1085 feet east of the POD (see Photo 1).

Photo 1. Aerial photo of the derailment looking northward

Approximately 3500 feet of track was destroyed and 1000 feet of track was disturbed. Train 308 was powered by 4 locomotives and was hauling 86 loaded grain cars. It weighed 11 318 tons and was 5355 feet long.

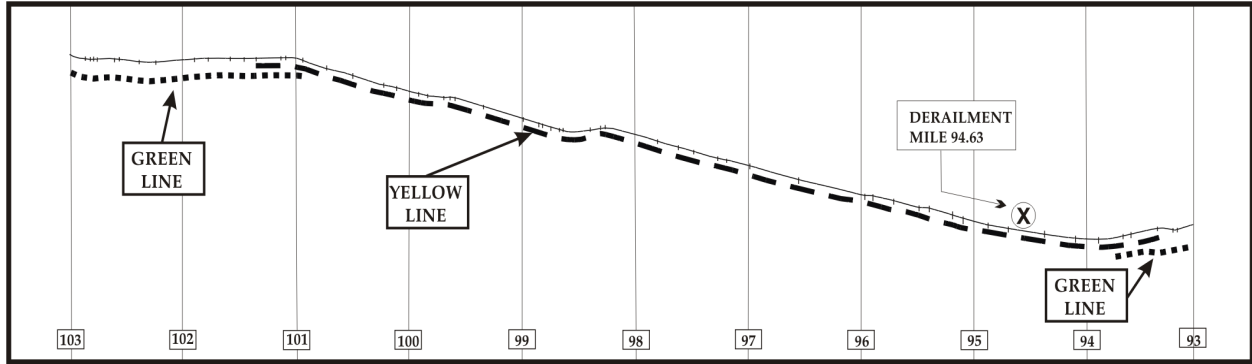
CPR provided train operating crews with a document entitled *Train Handling Guidelines Nipigon Subdivision*, which used colour-coded instructions to indicate the fuel-conserving method of train handling while travelling over the subdivision. The colour codes indicated green for throttle modulation, red for train air brakes, yellow for DB, or a combination of the colours for using a combination of these controlling methods (see Figure 1).

Figure 1. Guidelines for descending Bowker Hill

DB was indicated in the *Train Handling Guidelines Nipigon Subdivision* as the method to handle the train while descending Bowker Hill from approximately Mile 101.3 to approximately Mile 93.3. The guidelines were generic in that they did not apply to a specific type or size of train. Locomotive engineers may use the *Train Handling Guidelines Nipigon Subdivision* as a reference, but need to modify their train handling to account for differences in train make-up. New locomotive engineers were being trained to use DB wherever possible.

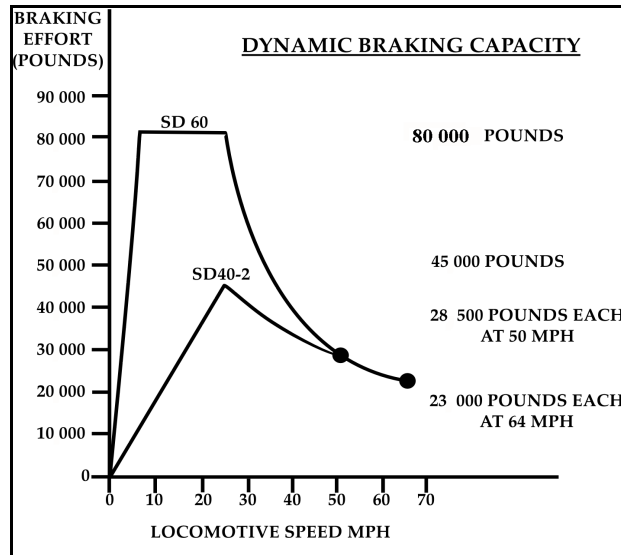
DB capacity is expressed in pounds of force (see Figure 2). DB is most effective at retarding a train under 25 mph. The combined DB capacity of the two locomotives declines from 125 000 pounds at 24 mph to approximately 57 000 pounds at 50 mph, and further declines to approximately 46 000 pounds at 64 mph.

Figure 2. Dynamic braking capacity
